The brick manufacturing process often includes materials containing lime. Measures are taken to minimize the lime present in brick bodies, but it is impossible to completely remove due to the nature of the raw materials and some of the oxides and coatings used to effect certain colors and textures. Occasionally larger particles of lime make it into the brick. If not fully dissolved in the clay during firing, some small pieces of lime may turn into quicklime. When pieces like this are located near the face of the brick they can result in lime pops. This happens because the lime is exposed to moisture and expands. This expansion can exert enough force to break small portions off the face of the brick.

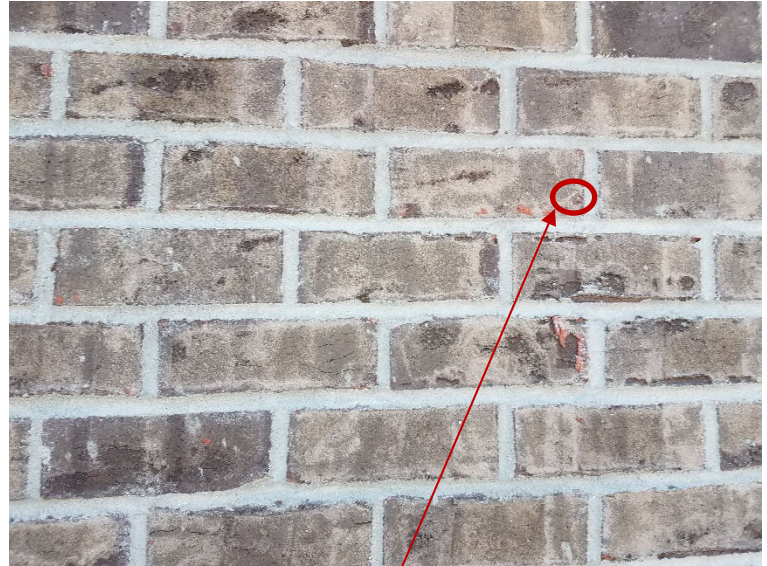
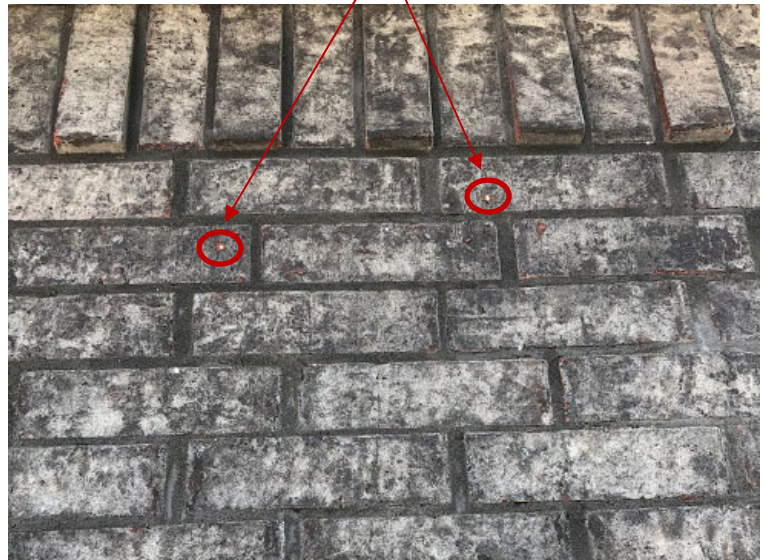
Lime Pops

Lime pops are usually small and not visible within the ASTM standard viewing range. They affect only parts of the surface area of the brick. Our experience indicates that any popping that is going to occur will happen during the first year the brick are in the wall as wetting and weathering of the walls will dissolve the lime spots and prevent further popping. If further popping does appear to occur after six months, it is usually caused by a loosening of particles which has already occurred and come off later in the weathering process. No physical or structural damage to the brick itself has been known to occur in General Shale Brick. Lime pops are a purely aesthetic issue and do not impact the durability or structural integrity of the brick.
