Manganese Staining

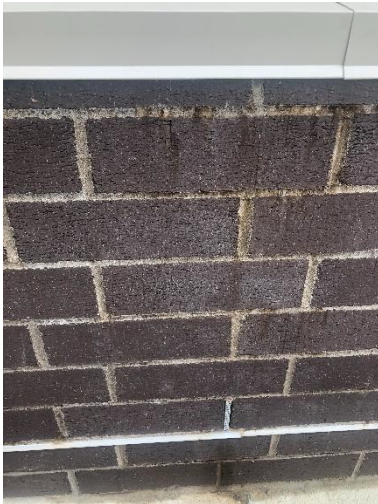
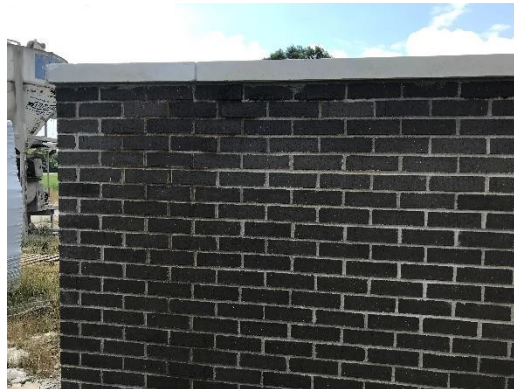
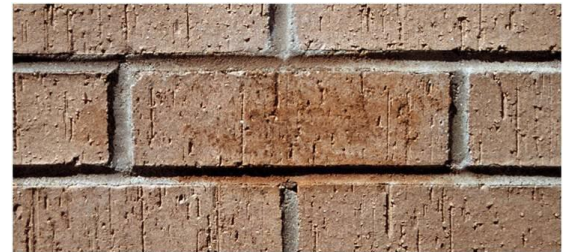
Manganese staining can occasionally occur in brick containing manganese compounds that are intentionally added as a coloring agent or to help darken the color appearance of the brick. Manganese stains are typically tan or brown in appearance and are sometimes referred to as “tobacco stains”.

During the brick firing process, the manganese compounds undergo chemical changes resulting in compounds that are insoluble in water however, these compounds can have varying degrees of solubility in weak acids. Once dissolved these manganese compounds can migrate to the surface of the brick work and typically reacts with the alkaline mortar joints to create an insoluble brown or tan “tobacco” colored stain.

The staining is usually caused during the cleaning process but excessive rain during construction can also cause manganese staining to occur. To prevent this staining, it is recommended to protect wall cavities and keep brick cubes dry during construction. There are also proprietary chemical cleaners that help prevent manganese staining from occurring.

Once manganese staining has occurred there are proprietary cleaners such as *One Restore* by EaCo Chem which will readily and easily remove the stain. This stain removal process does not require an overall re-cleaning but can be done on a spot cleaning basis. After removing the stains, they typically will not reoccur if there is not any excessive water migration into the wall.
